MANDATORY BULLETIN

N° BO 13/99

NAME - TYPE / MODEL: MDM-1 „Fox”

CONCERNS: Enlarging of removable balancing weight and revision to rear limit of allowed C.G. position of empty glider (which results in necessity of permanent correction weight installation on MDM-1 FOX type gliders).

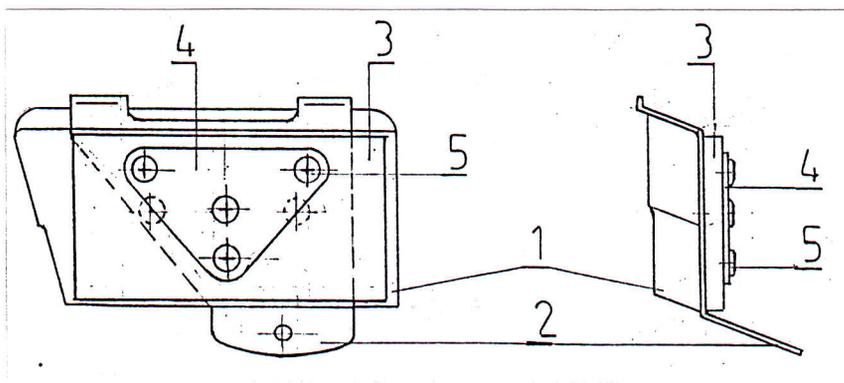
4.1. Correction of removable balancing weights' mass:

Necessary modification includes enlarging mass of removable balancing weights, required while flying with lightweight crew. These are changed from 8.5 kg to 11.0 kg by installation of two segments, weighing 1.25 kg each.

- 1- existing ballast
- 2- existing ballast's fastening plate
- 3- lead plate
- 4- steel cap
- 5- screws

- place lead plate (3), together with steel cap (4) over existing ballast (1). After adopting these to match each other, drill 4 holes through the lead of existing ballast and its fastening plate. Use the new steel cap together with lead plate to pilot the newly drilled holes;

NOTE: DRILL CAREFULLY IN LEAD; APPLY LUBRICANT ON THE DRILL

- after the holes are drilled, fasten the whole set with 4 screws (5).
- The manufacturer supplies with this Bulletin: additional balancing weights, steel caps, drill, 12 screws (including 4 spare ones).

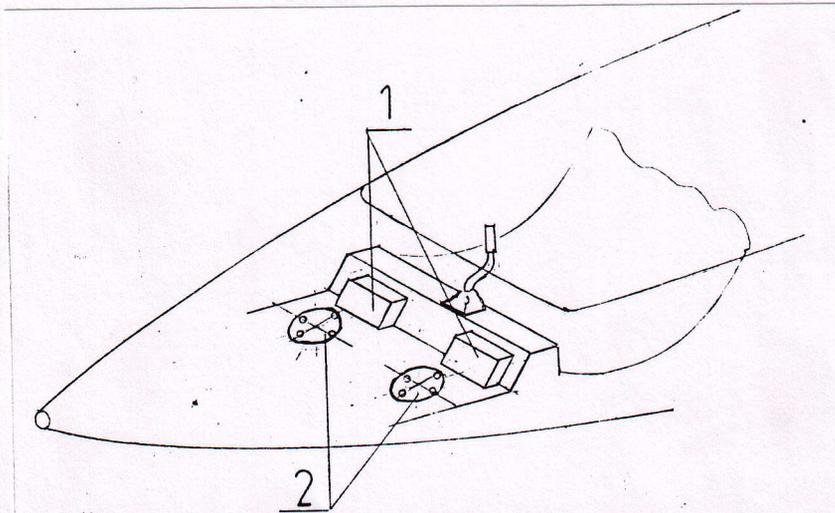
4.2. Correction of empty glider C.G. location:

Additionally, in gliders with Factory Nos. P-15, P-16, 205, 206, 209, 212, 213, 214, 216, 217, 218, 219, 220, 221, 221, 222, 223, 225, covered with this Bulletin, it is necessary to introduce a permanent weight of 1 to 3,5 kg - depending on particular glider. This ballast should be installed inside one of two intended for this purpose chambers, located in front of the front seat, below location of removable balancing weights installation.

1- removable ballast
2- ballast chambers
covers

- unscrew 4 screws fastening ballast chamber cover, and remove the cover;
- place bag with lead shots (correction weight) inside ballast chamber;
- in order to prevent the ballast from moving inside the chamber, fill remaining empty space tightly with foamed polystyrene granulate supplied with Bulletin;
- place and screw the cover on.
