BULLETIN No BE-103/93 SWIFT**Concerns :**

Inspection of the leading edge area over the wing root portion after completion of 100 flying hours, and then every next 50 flying hours, or before the begin of the next flying season. Single inspection of the condition and clearness of the drainage openings.

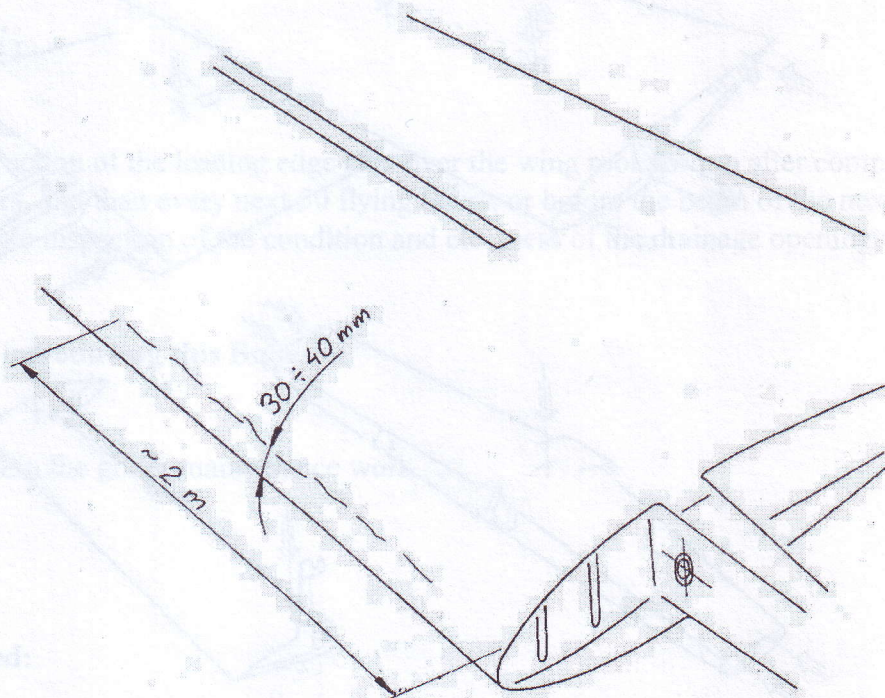
Described damage to wing leading edge have been found on the left hand panel of the first flying prototype, Fact No P-05, after completion of approx. 80 flying hours. On this particular glider the complete flight test program has been realised, including the flight envelope extension up to the required-, and also possible to be encountered in flight, extension of glider operating limitations. After completion of the test program the glider has been subjected to the detailed technical verification, no any damage to the glider load carrying structure have been detected.

Fig. 1 Lacquer cracks at wing leading edge

Verify if on the wing top surface, 30 through 40 mm from the leading edge line (measured along the wing contour) no plainly visible lacquer cracks have appeared, oriented parallel to leading edge line, intermittent or overlapping ones. Under the cracks of lacquer coat the damage to outer layers of composite structure may be present in a form of white spots or microcracks.

Area on which cracks are probable covers the root portion on both wing panels, extending spanwise over approx. 2 meter distance (from root rib). Approximate form of the described lacquer cracks is illustrated in the sketch enclosed above on this page.

In case of appearance of the damages as described at the wing leading edge of your glider, you are kindly requested to urgently contact the Producer, as well as to temporarily stop glider operation, until clearing all doubts around glider airworthiness.

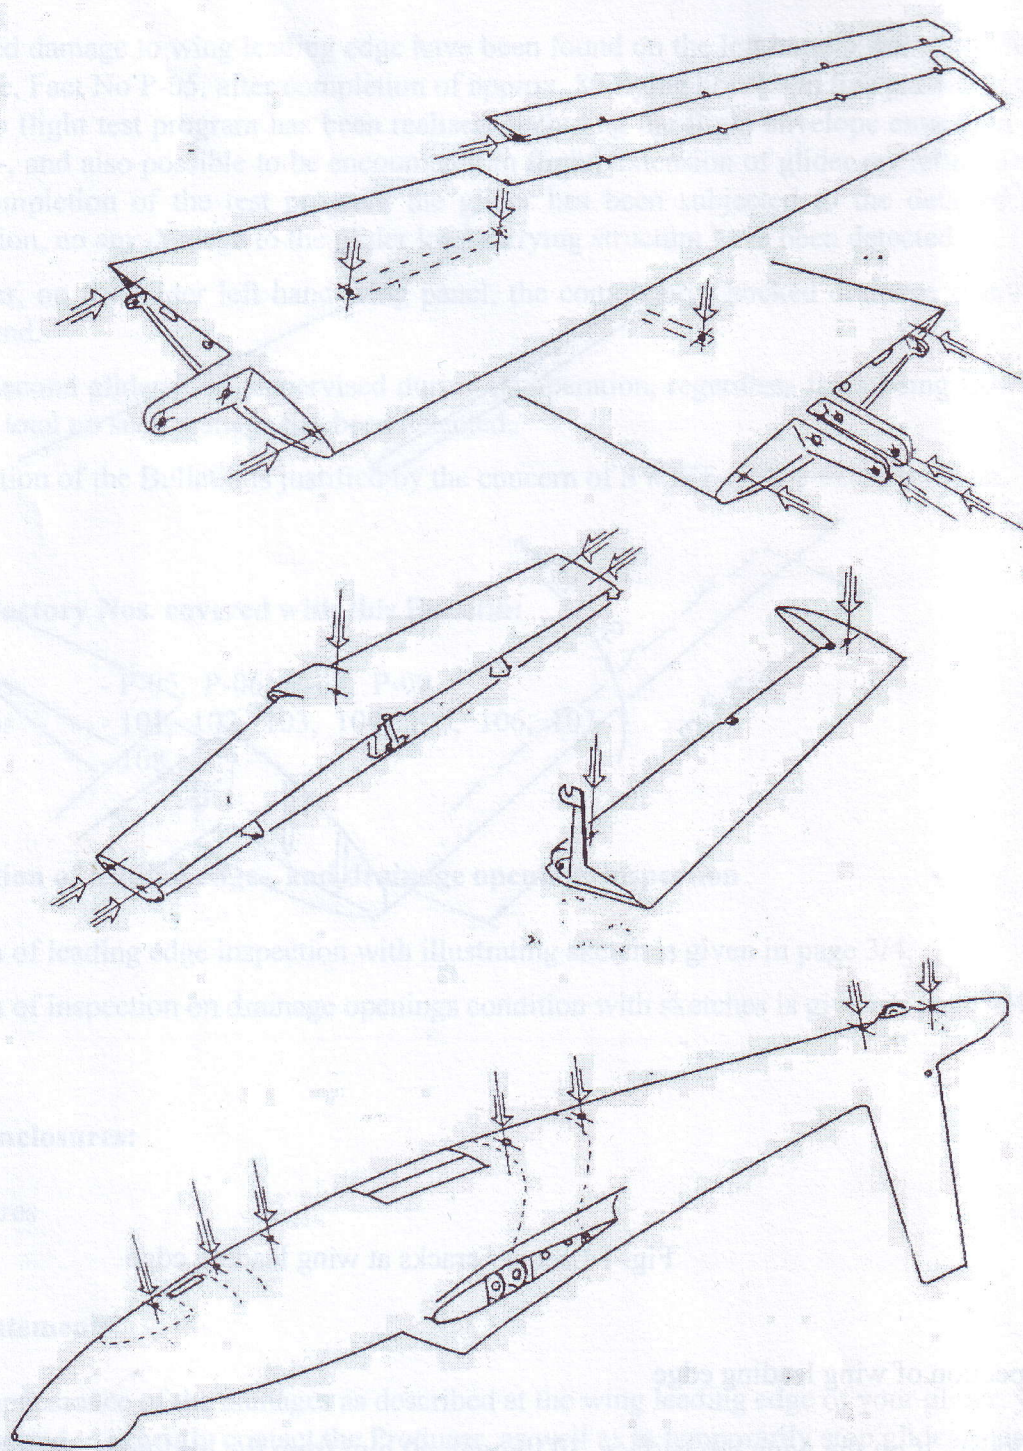
Moreover, on the glider left hand wing panel, the completely choked drainage openings have been found.

Fig. 2 Location of the airframe drainage openings 4÷5 mm

Description of inspection on drainage openings condition with sketches is given in page 4/4.
