## BULLETIN NO 107/94 SWIFT

Date of issue: 15. June 1994

Ref: Radio cable layout improvement

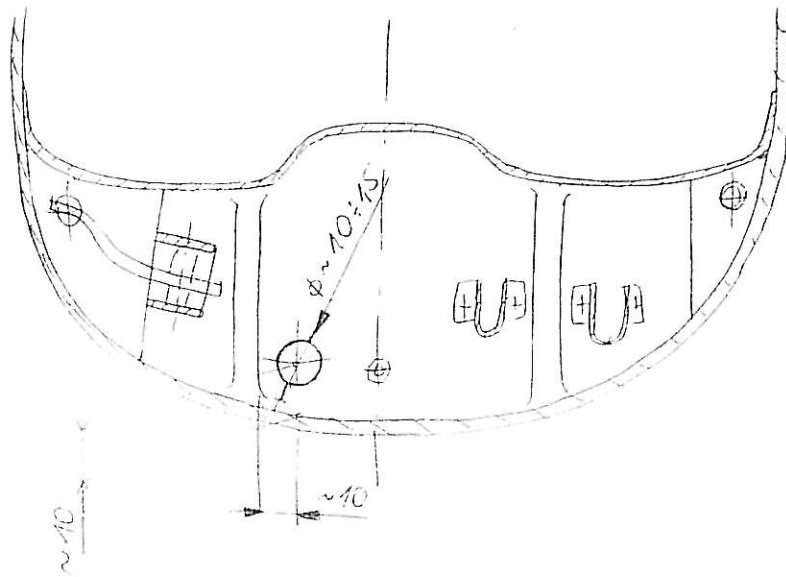
Fig. 1.

looking aftwards

There is a possibility to improve the radio cable layout through drilling small holes in both walls - before and behind the control stick (look Fig.1) and let the cable run through them.
