SERVICE BULLETIN No BO-115/2022 SWIFT S-1

Inspection of front node in tailplane mount, and
repair with modification – as necessary

REPAIR/ MODIFICATION INSTRUCTION TAILPLANE FRONT MOUNT SWIFT S-1

Doc. No: A2-OR-01/2021

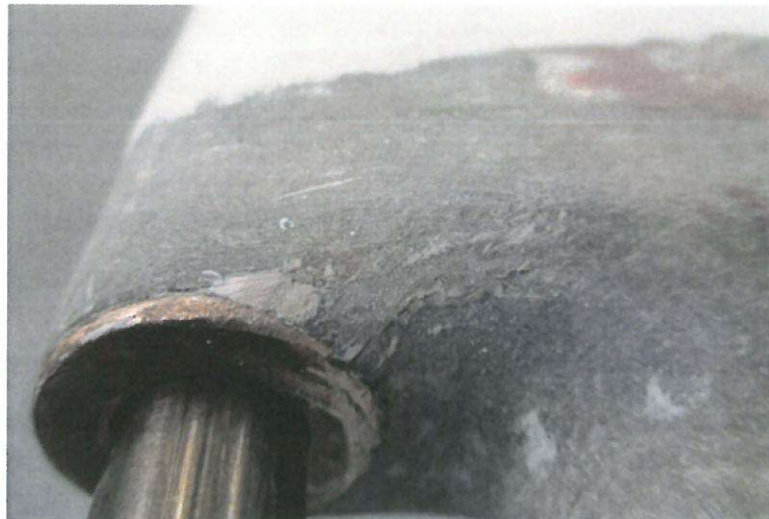
- on assembled glider, a perceptible play on the stabilizer front mount (fitting),
- on tailplane disassembled from a glider, the cracks penetrating into composite structure of the „console” (item 5 in Dwg No A/2-3.01.000 Tailplane), visible on outboard surfaces on both sides close to the front fitting sleeve
- after removing lacquer coat from the front fitting area, visible cracks and delamination in the “console” glass fabric

4. Every detected damage must be repaired before the next flight. If the nature of damage matches the description in the document – repair by the method including the design change, described in [1] REPAIR / MODIFICATION INSTRUCTION ..., see item 6. ENCLOSURES. The proposed change, by introducing additional elements supporting the fitting sleeves, contributes to a more even distribution of forces in the fitting composite elements and increases its resistance to the encountered type of damage.

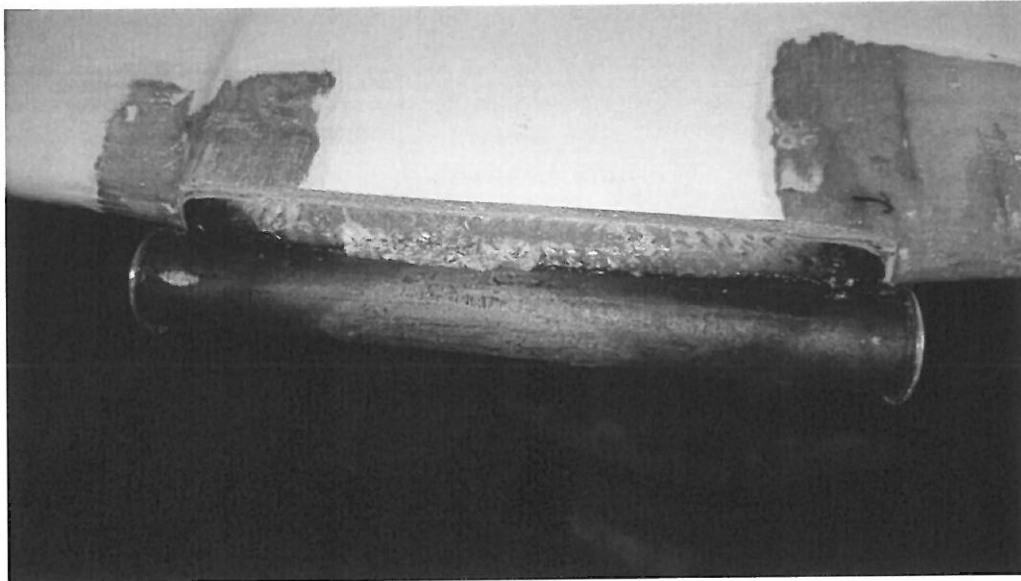
- the adhesive has been applied only under the central part of the tube with the fitting sleeves (manufacturing defect - no support under the sleeves),

- the play between metal elements of the front fitting (mounting bolt / sleeves of the stabilizer front fitting) close to its allowed size specified in the glider Maintenance Manual - considered an evidence of wear, also signs of corrosion on the tube, moisture and rust on the surface of the composite console,
- after removing the outer composite layers, no signs of damage on the exposed console foam block,

The identified causes of the damage are: design features and defects in production process.

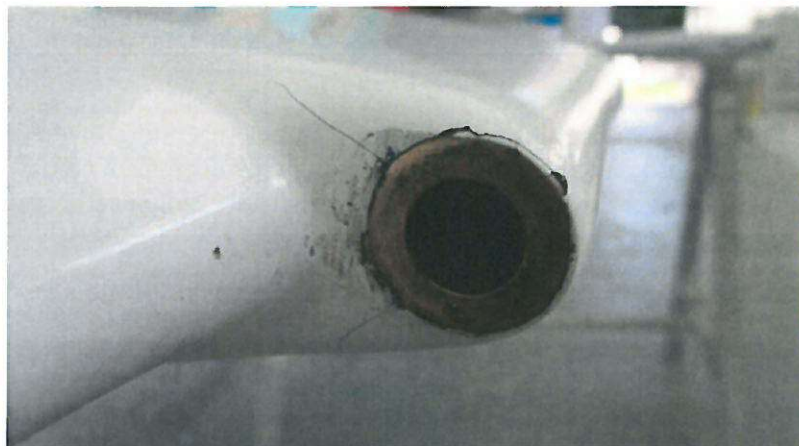
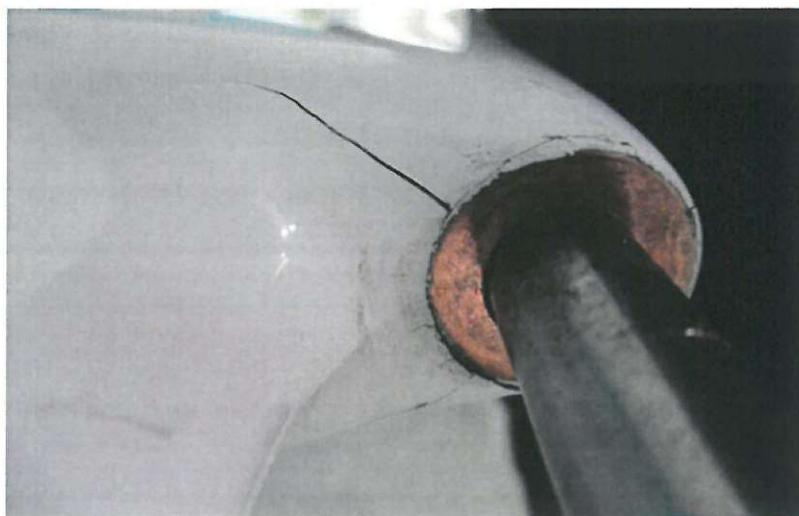
Possible form of damage to the tailplane front mounting node.

3. Examine the extent of each crack detected on the surface of composite elements: check if it is confined to the layer of lacquer and putty, or penetrates into the composite. To do this, carefully remove the lacquer from the fracture area and check the exposed composite for cracked fibers and / or white spots evidencing damage to the composite.

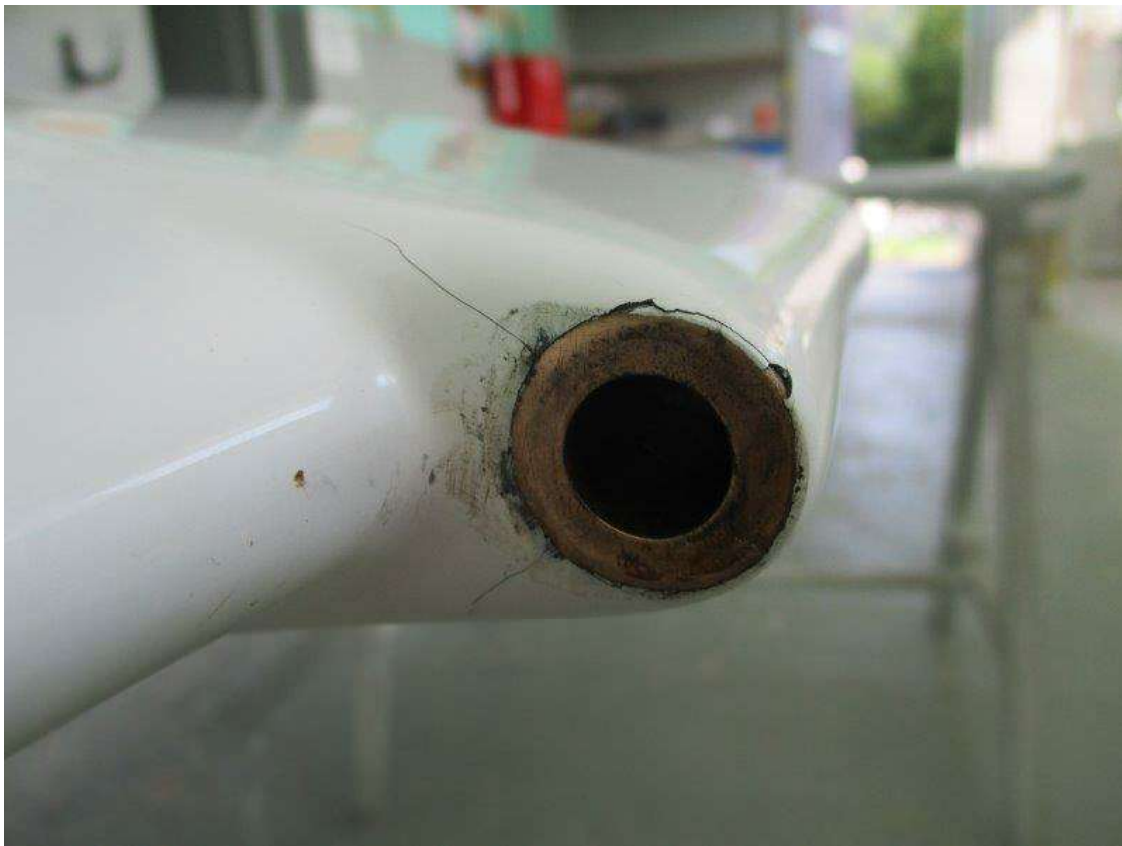
- on assembled glider, clear evidence of enlarged play on tailplane front fitting
- on tailplane disassembled from the glider, cracks penetrating into composite structure of the „console” (item 5 in Dwg No A/2-3.01.000 Tailplane) visible in the area of installation of the front fitting sleeve, on outboard surfaces on both sides

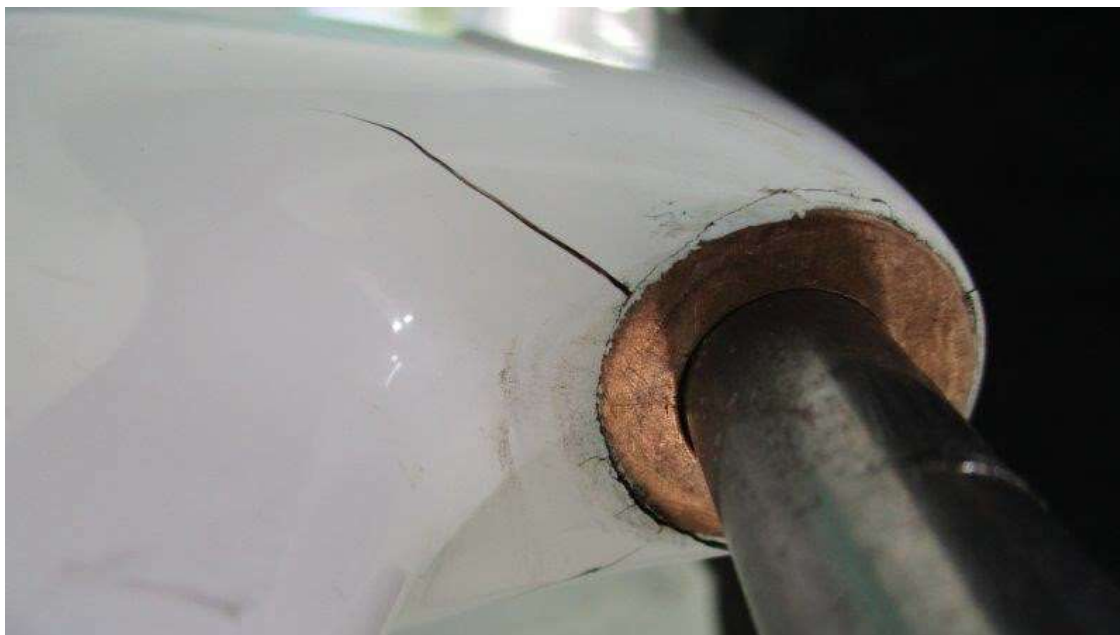
- when checking a bonded joint between the metal front fitting and composite, by moving (front-back, up-down) the bolt inserted into the fitting sleeve - size of the crack gap significantly widens, the stabilizer metal fitting moves freely

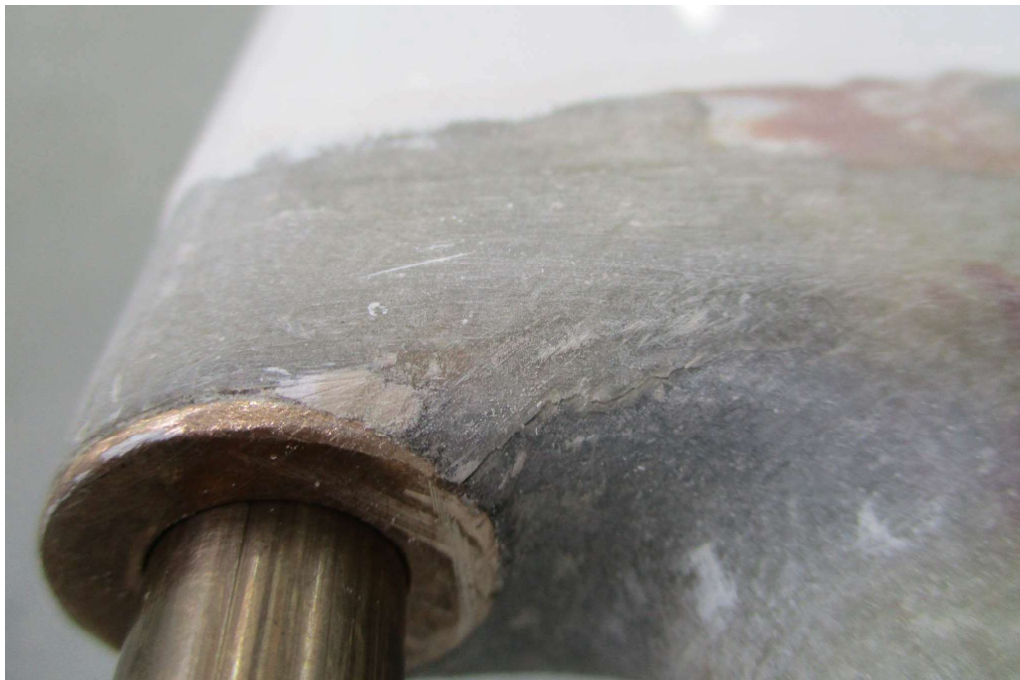
- after removing the lacquer coat in the area of „console” damage, discovered cracks and delamination in reinforcement fabric layers on the outboard surface of this element

- cracks of „console” side webs, propagating from the fitting sleeve in directions +/- 45 deg in relation to the plane of chord
- disbonding of the fitting metal sleeve /damage to adhesive in bonding joint and “console” tapping/

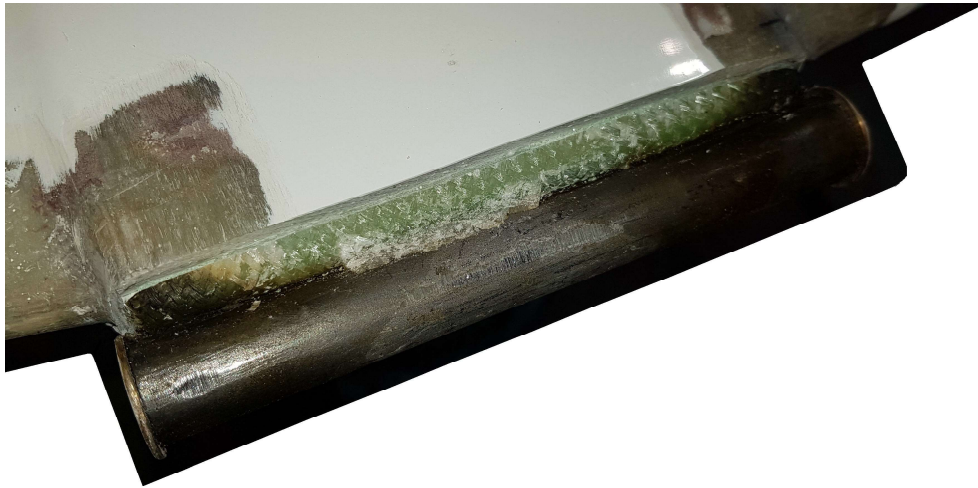
- missing adhesive between the composite and the front fitting metal tube (production fault)
- no protective layer of BWF-21 glue on surface of the fitting metal tube (production fault) + corrosion - see figure below)
