SERVICE BULLETIN No BO-115/2022 SWIFT S-1

Inspection of front node in tailplane mount, and
repair with modification – as necessary

REPAIR/ MODIFICATION INSTRUCTION TAILPLANE FRONT MOUNT SWIFT S-1

Doc. No: A2-OR-01/2021

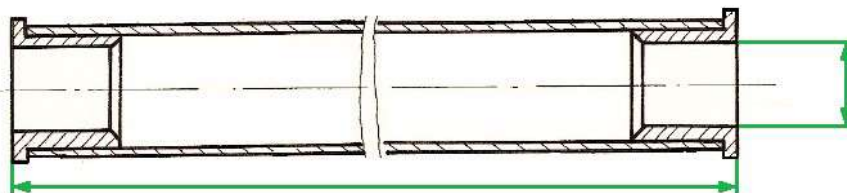
STEP 3

- DAMAGE
- EXCEEDING ALLOWED PLAY ($\Delta=0,10\text{ mm}$)
- LACKING PROTECTIVE COAT BWF-21
 (CONCERNS METAL COMPONENTS OF FITTING)

1. EVALUATE TECHNICAL CONDITION OF DISMOUNTED METAL FITTING
2. VERIFY PLAY IN CONNECTION BETWEEN MATING ELEMENTS OF FRONT FITTING (SLEEVES IN FUSELAGE/ IN STABILISER – BOLT)
(SEE TECHNICAL SERVICE MANUAL OF THE GLIDER
- item 2.5 Allowed assembly play)

ORDER THE NECESSARY COMPONENTS AT PRODUCER, SPECIFYING REPAIR DIMENSIONS NECESSARY FOR CORRECT MATING

USING COMPONENTS WITH REPAIR DIMENSIONS REDUCE PLAY TO APPROX. 30% OF ALLOWED VALUE

3. EVALUATE TECHNICAL CONDITION OF FOAM BLOCK – IN CASE OF VISIBLE DAMAGE (INDENT, LOSS) RECONSTRUCT THE BLOCK WITH HEREX C 70.55 FOAM

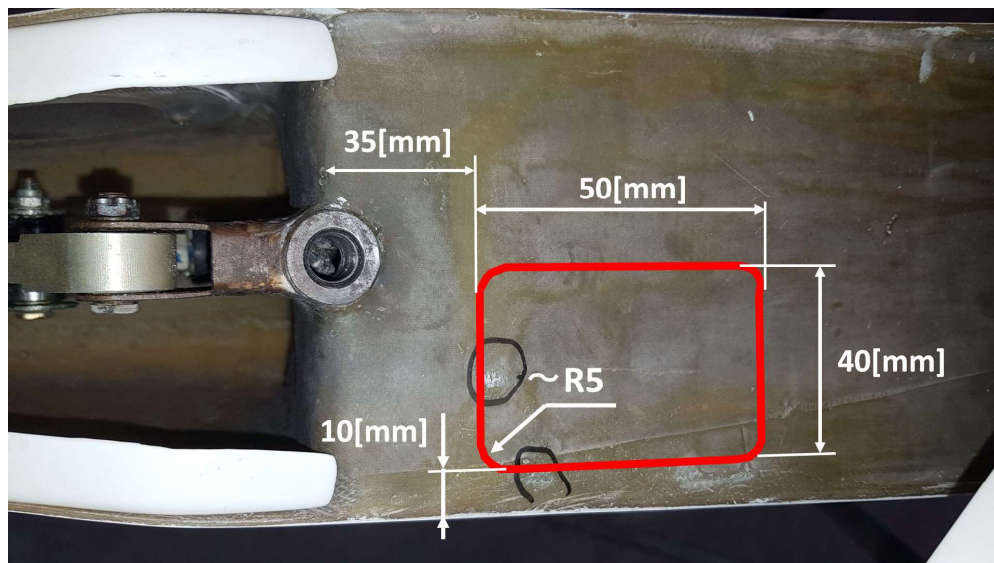
STEP 1

In case of insufficient clearance between the modified stabiliser and rear web in fuselage (found on the first glider repaired in accordance with this Instruction ..., resulting of incorrect, oblique web positioning in production), correct as follows.

Cut the opening as in sketch below (approx dimensions corresp. to the condition on the 1- st repaired glider).
